Component Details

Inventory

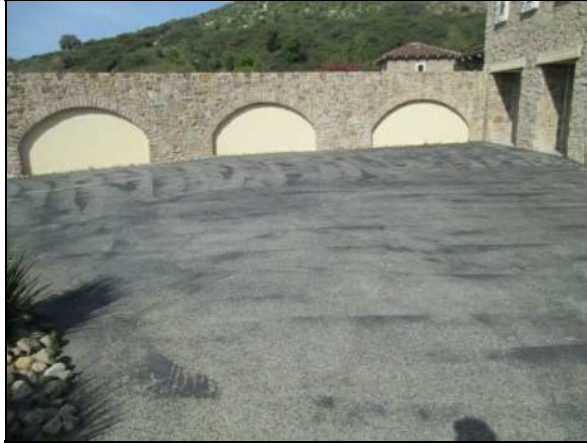
Comp #: 201 Asphalt - Remove/Replace (Parking)**Quantity: Approx. 15,500 GSF**

Comments: Moderate deterioration, discoloration and aging observed throughout. No major damage witnessed. Asphalt is in serviceable condition.

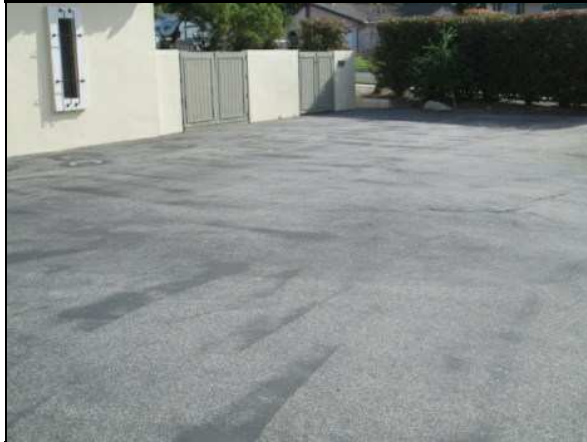
Comp #: 202 Asphalt - Seal/Repair**Quantity: Approx. 15,500 GSF**

Comments: Surfaces show moderate to heavier discoloration and wear at this time. Seal is in declining condition. Stick to reseal cycles to maintain this asset.

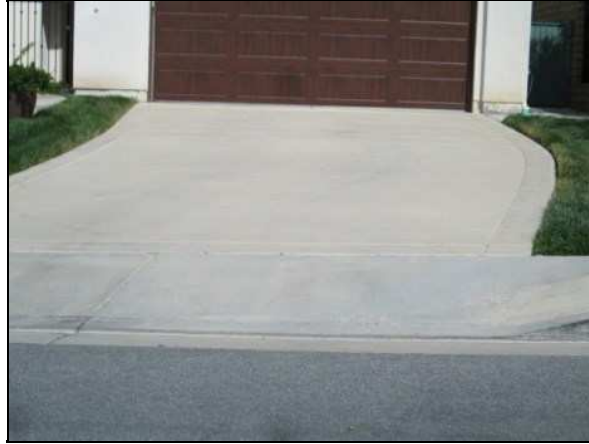
Comp #: 205 Concrete Drive - Repair

Comments: The concrete surfaces are intact and aging normally. No signs of advanced cracking or deterioration. Best to inspect, repair, and pressure-wash as needed as an Operating expense. There is no expectation for significant replacement at this time. No Reserve funding required.

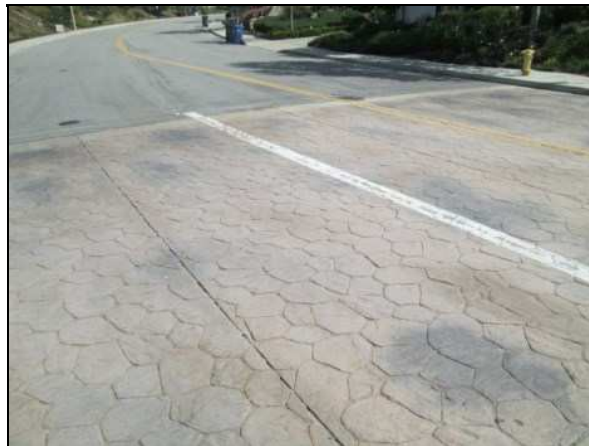
Comp #: 206 Stamped Concrete - Restain

Comments: The stamped concrete is reported to be the responsibility of the city and not the HOA to replace. Surfaces are discolored and worn at this time. Funding has been provided for periodic re-staining to maintain appearance.

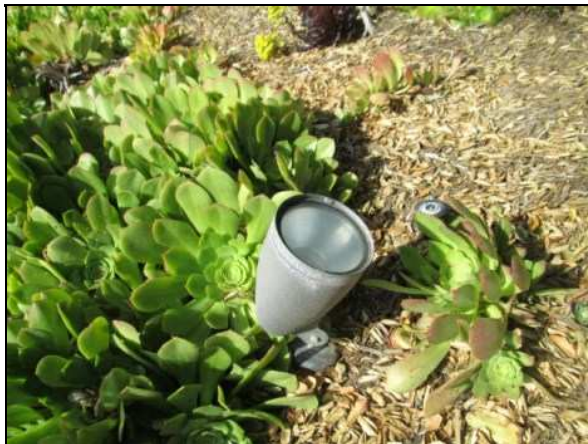
Comp #: 321 Landscape Lights - Replace

Comments: Inspected during daylight hours, but assumed functional. No severe damage or abuse detected. In fair overall condition.

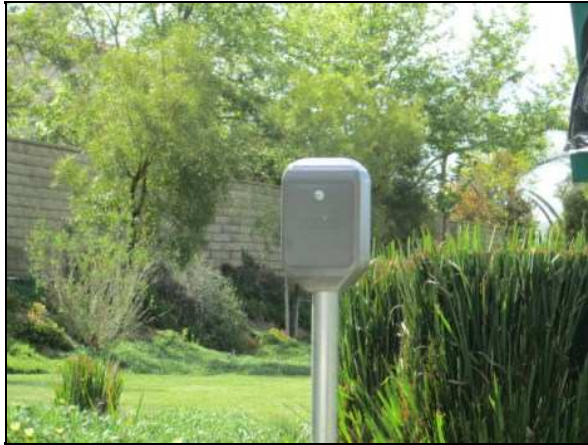
Comp #: 346 Solar Boxes - Replace

Comments: Reported to be handled as needed as an operating expense. No Reserve funding is required.

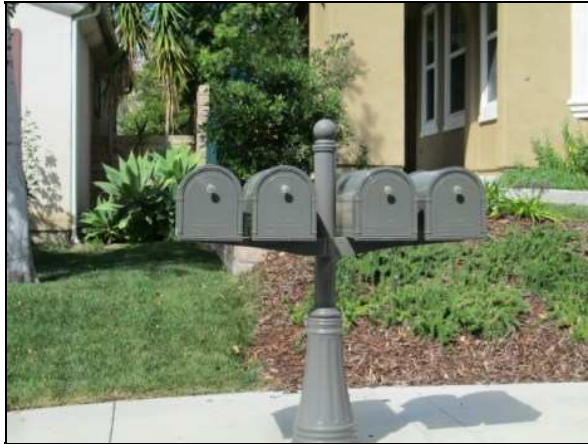
Comp #: 403 Mailboxes & Posts - Replace

Comments: Boxes and posts are upright, sturdy and aging well at this time. No advanced deterioration noted. In fair condition.

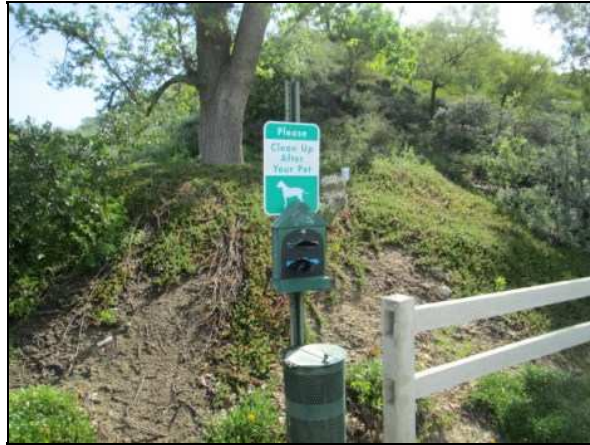
Comp #: 406 Dog Stations - Replace

Comments: Stations are fully serviceable and in fair condition. Funding has been provided for periodic replacement.

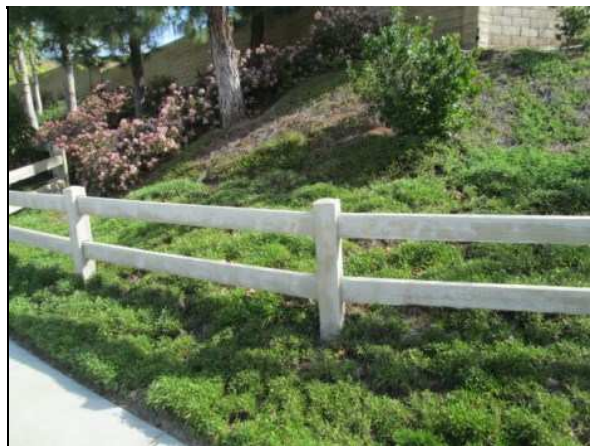
Comp #: 507 Split Rail Concrete Fence - Repair

Comments: There is no expectation to replace all at once. Funding has been provided for annual repairs/partial replacements to maintain this asset.

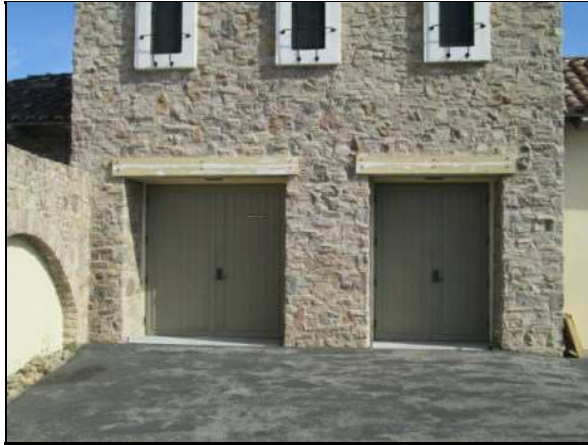
Comp #: 701 Front Doors - Replace

Comments: Doors are sturdy and intact at this time. No advanced damage or abuse observed. In fair overall condition.

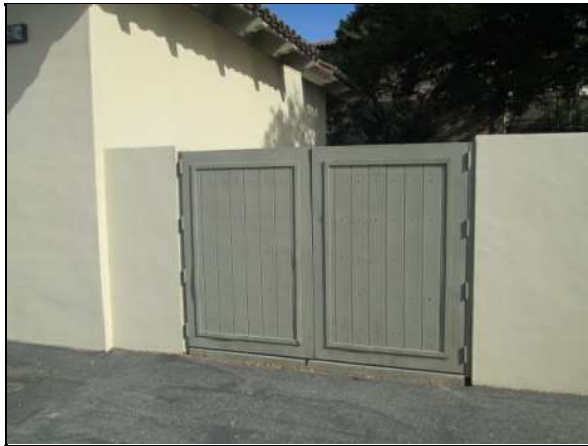
Comp #: 708 Trash Gates - Replace

Comments: Gates appear to be aging normally at this time. No advanced deterioration noted. In fair condition.

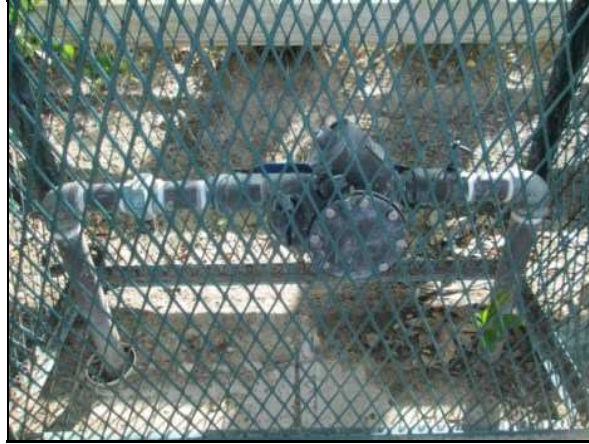
Comp #: 1001 Backflow Devices - Partial Replace

Comments: The backflows were not tested during inspection. Best to have the devices inspected and maintained on a regular basis by a certified plumbing vendor. These devices prevent harmful chemicals from backwashing into your drinking water supply. Reserve funding provided for periodic partial replacement.

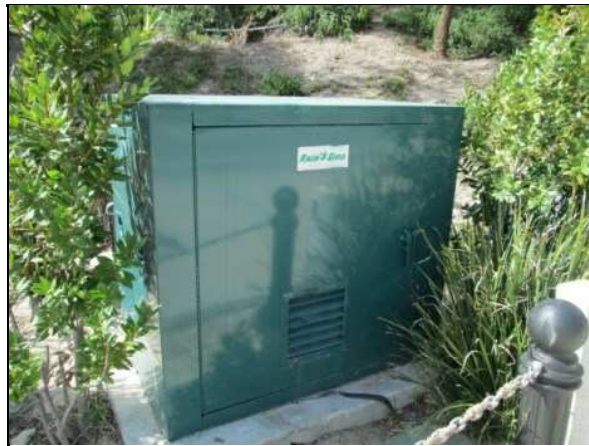
Comp #: 1002 Irrigation Pumps - Replace (A)

Comments: All pumps are functional. No problems reported at this time. Association made repairs in 2018. In fair overall condition.

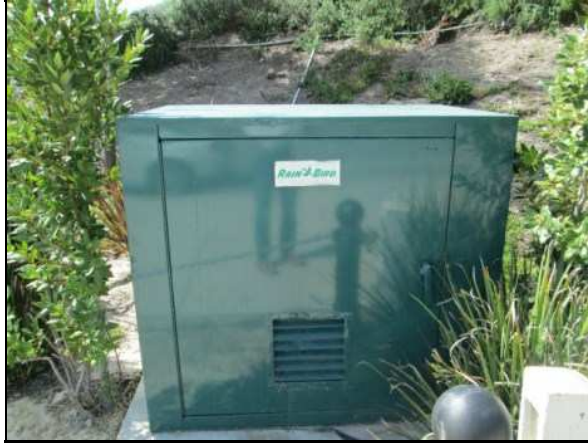
Comp #: 1002 Irrigation Pumps - Replace (B)

Comments: It was reported that (4) pumps have recently been replaced. Expect full useful life.

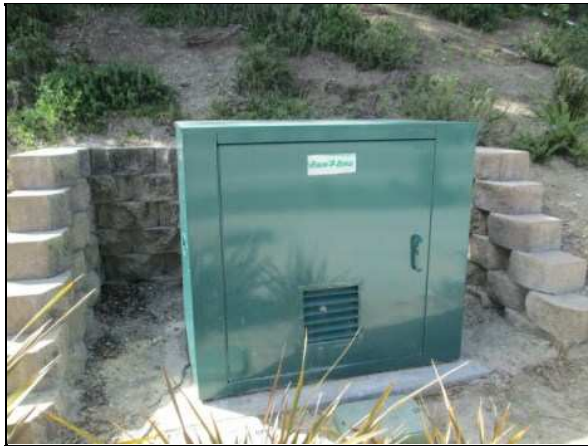
Comp #: 1002 Irrigation Pumps - Replace (C)

Comments: It was reported that (4) pumps have recently been replaced. Expect full useful life.

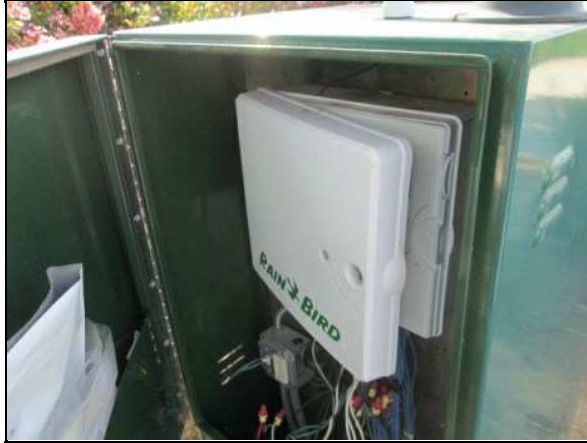
Comp #: 1003 IQ Irrigation Controllers - Replace

Comments: All irrigation controllers were replaced with an IQ, smart irrigation system that can be completely monitored and controlled via the internet. No reports of problems at this time. In fair condition.

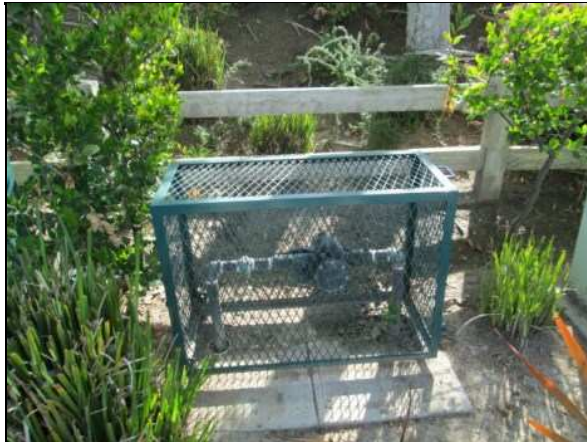
Comp #: 1004 Backflow Enclosures - Replace

Comments: General wear/tear and deterioration detected during inspection. In fair overall condition. Plan on eventual replacement.

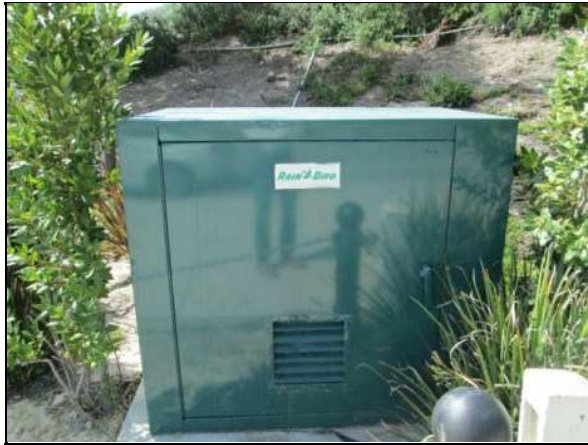
Comp #: 1004 Pump Enclosures - Replace

Comments: Enclosures are intact, serviceable and all open/close properly. In fair condition. Best to repaint periodically to prevent rusting.

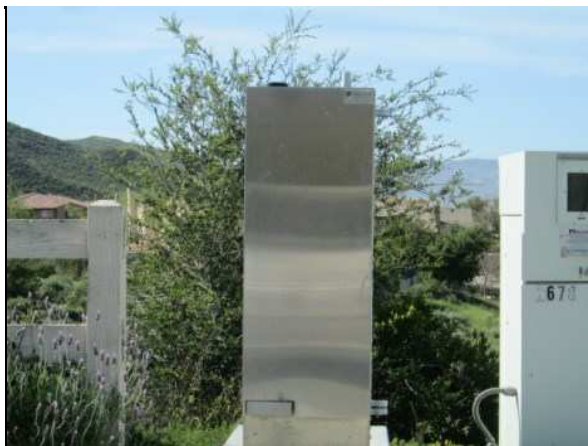
Comp #: 1004 Time Clock Enclosure - Replace (SS)

Comments: Enclosures appear to be aging normally, with moderate wear observed. In fair overall condition.

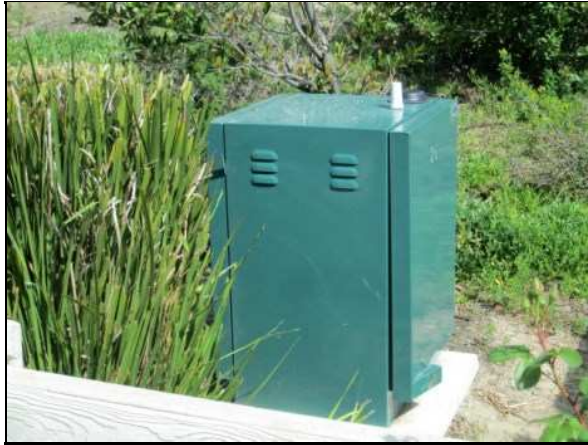
Comp #: 1004 Time Clock Enclosures - Replace

Comments: Moderate wear/tear and aging detected, but no severe damage evident. In fair condition.

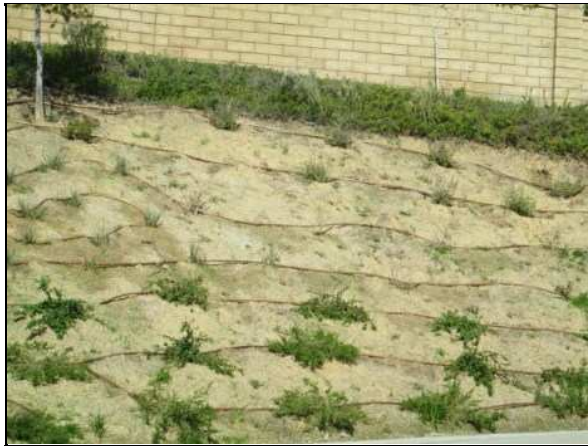
Comp #: 1005 Irrigation System - Refurbish

Comments: Funding has been provided for annual refurbishing at the request of the client.

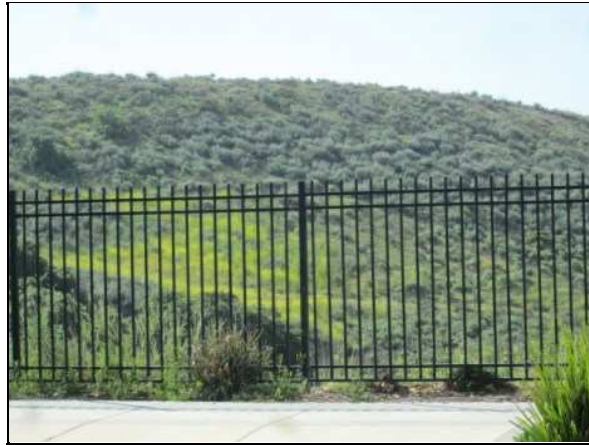
Comp #: 1107 Galvanized Fence - Repaint (50%)

Comments: Surfaces exhibit moderate wear/tear and fading. Paint coverage is in fair condition. Stick to repaint cycles to maintain this asset.

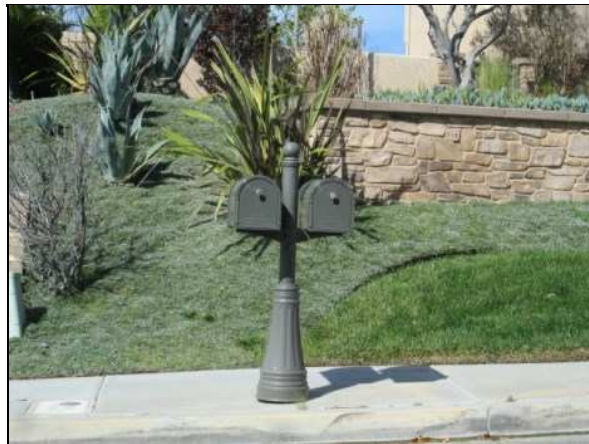
Comp #: 1114 Mailboxes - Repaint

Comments: This type of painting project has a (10) year warranty. Expect to alternate with the schedule of replacement (see #403). In fair condition.

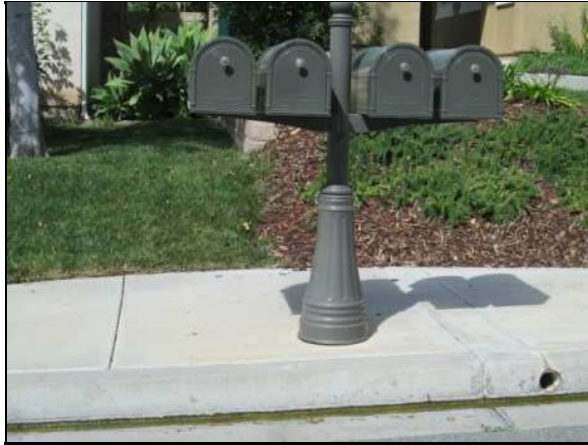
Comp #: 1114 Mailboxes Stands - Repaint

Comments: General aging and light wear evident. Paint coverage is in fair overall condition.

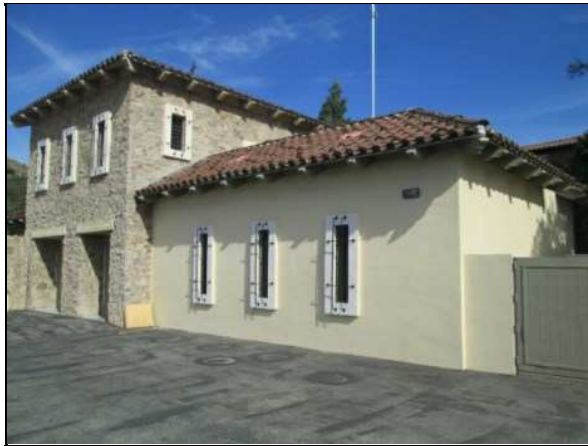
Comp #: 1115 Waterscape Building - Repaint

Comments: Surfaces exhibit minor grime build-up and weathering. Paint coverage is in fair overall condition.

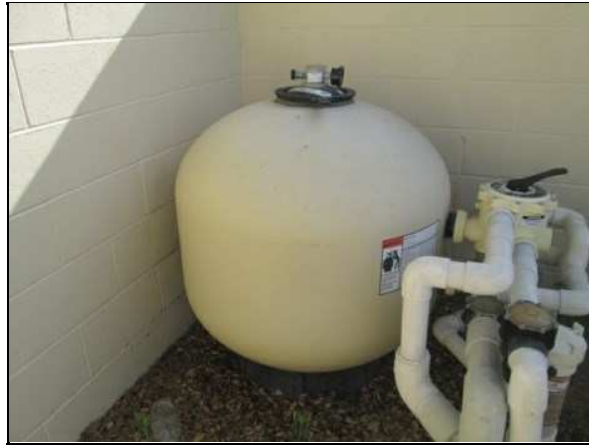
Comp #: 1207 Waterscape Filter - Replace

Comments: Filter appears to be aging well, with no active leakage observed. In fair condition.
S/N: 01011911400371, Date: 7/10/2014.

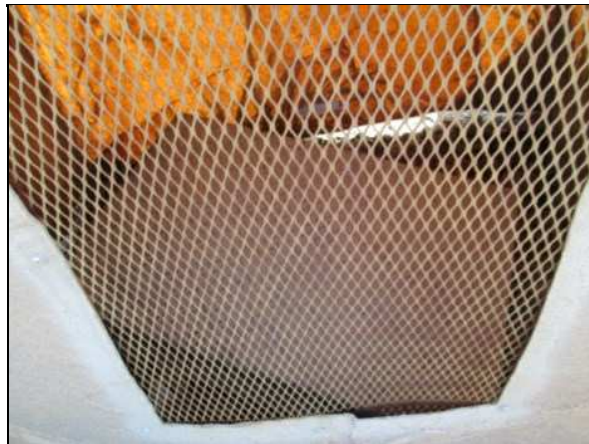
Comp #: 1210 Waterscape Pump - Replace (large)

Comments: No access to inspect. Much of the pump remains original (2005). Based on repairs and refurbishment, remaining useful life was extended, but anticipate the need for replacement in the near future.

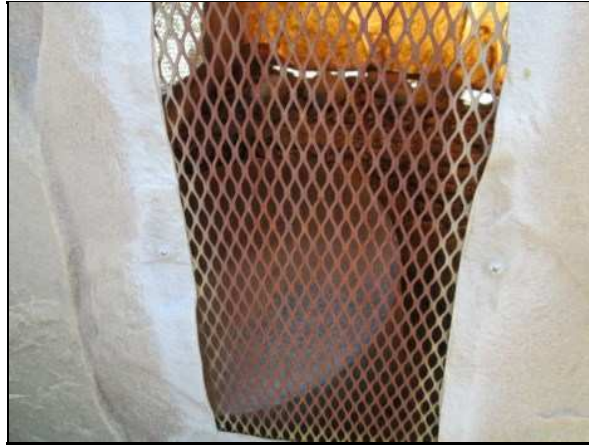
Comp #: 1210 Waterscape Pump - Replace (small)

Comments: No access to inspect. Reported to be functional, with no service related issues. Expect full useful life.

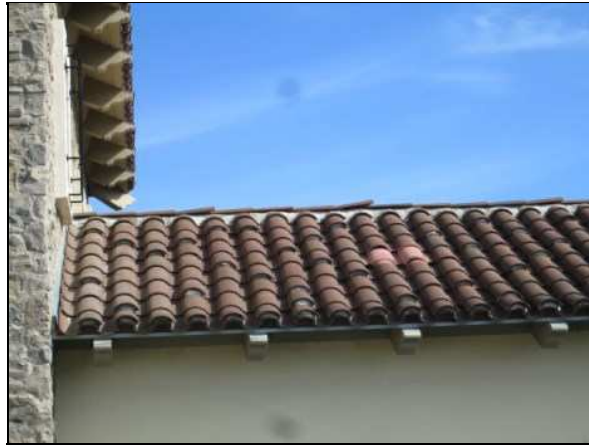
Comp #: 1304 Tile Roof - Replace Underlayment

Comments: The tiles are intact and properly aligned. No reports of water intrusion. The underlayments beneath the tiles will need to be replaced every 20-30 years. A typical project involves removing and stacking existing tiles, replacing all underlayment material, and then re-laying tile. An allowance for some tile breakage is included in these costs.

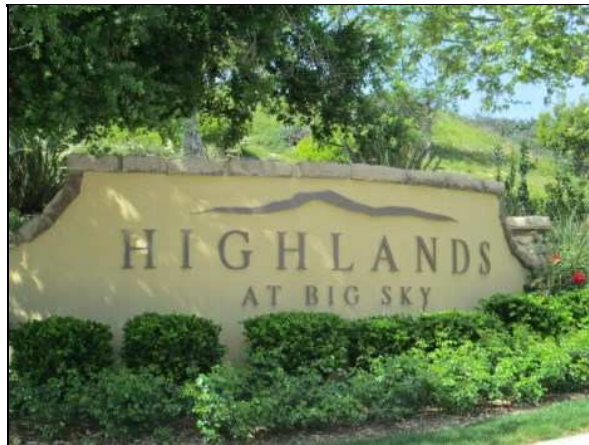
Comp #: 1402 Monument Signs - Refurbish

Comments: Signs are intact, attractive and aging well at this time. In fair overall condition. Plan on periodic refurbishing to maintain appearance.

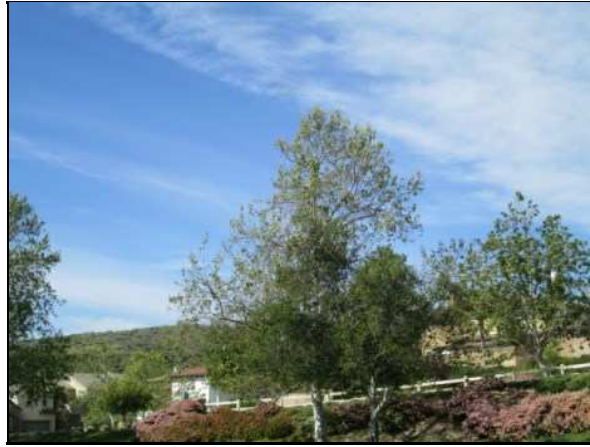
Comp #: 1808 Trees - Trim/Remove/Replace

Comments: Funding has been provided for annual work at the request of the client.

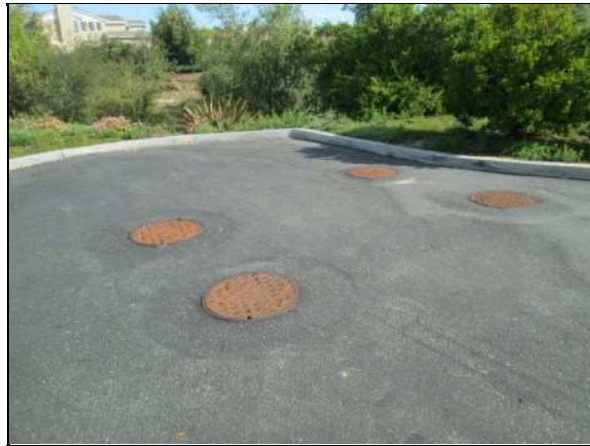
Comp #: 1831 Vortex Drains - Maintenance

Comments: The drains are reported to be fully functional, with no issues at this time. In good condition.
